Indicative fire test

175102

**Samuel Heath & Sons
PLC**

The purpose of the test was to provide an indication of the performance of a timber door leaf construction incorporating a Perko – Powermatic R100 door closer, when exposed to the heating conditions specified in BS 476: Part 20: 1987.

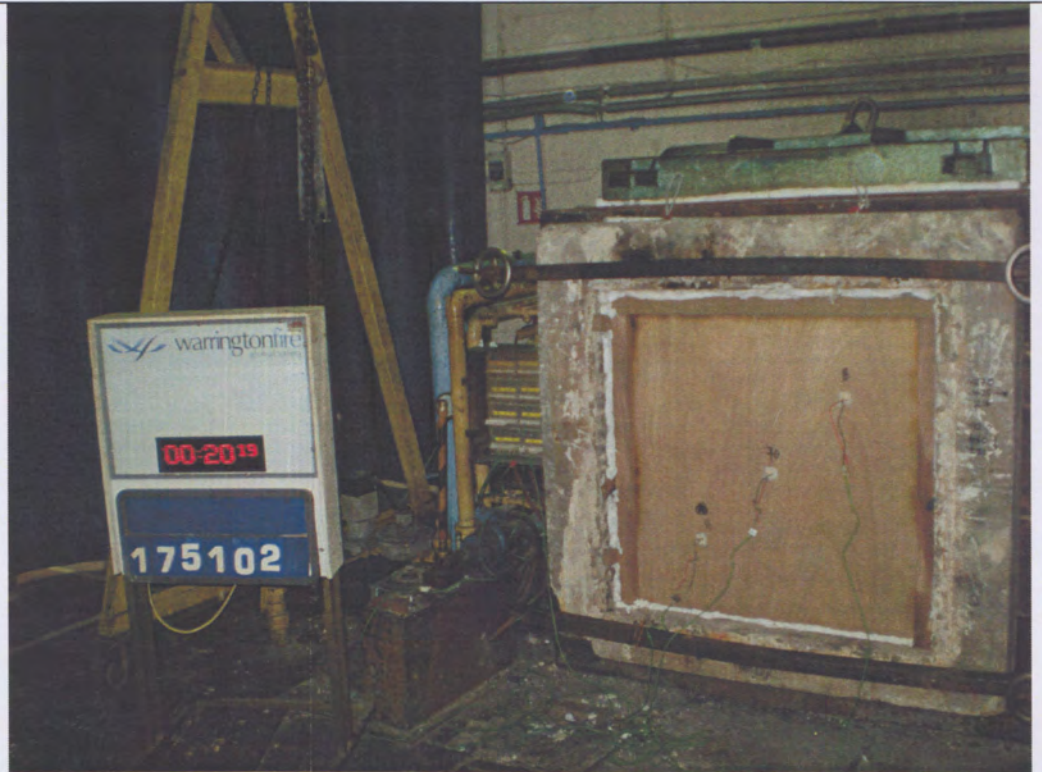
The unexposed face of the doorset after a test duration of 20 minutes

Time		All observations are from the unexposed face unless noted otherwise.
mins	secs	
00	00	The test commences.
02	00	Smoke release is evident from the head of the doorset.
04	00	The exposed surface of the doorset ignites and begins to char.
06	30	The smoke release mentioned at 2 minutes stops.
12	00	Slight smoke release is evident from the top of the leading edge of the doorset.
16	00	Slight smoke release is evident from the top of the trailing edge of the specimen.
22	00	The smoke release mentioned at 16 minutes descends along the trailing edge.
25	00	Pulses of smoke issue from adjacent to the closer position.
27	00	The smoke release mentioned at 25 minutes increases in volume.
32	00	Slight discolouration is evident adjacent to the closer position.
40	00	Crackling sounds are heard from the doorset.
50	00	Due to the large volume of flames within the furnace chamber, exposed surface observations are very restricted.

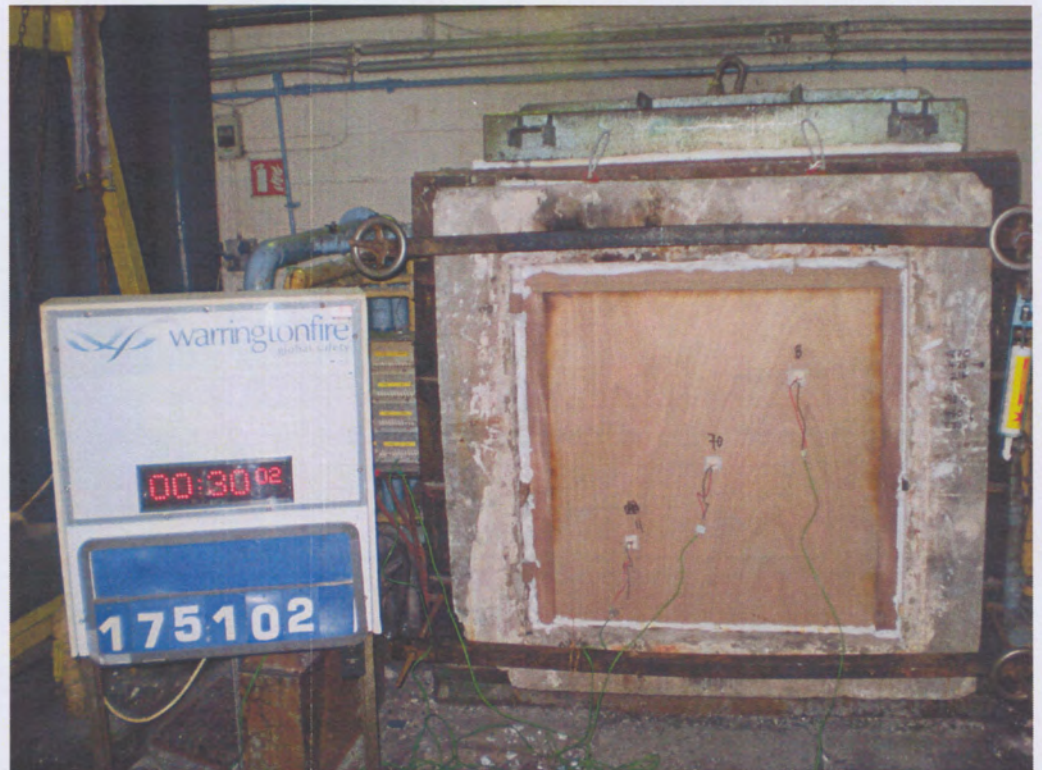
The unexposed face of the doorset after a test duration of 30 minutes

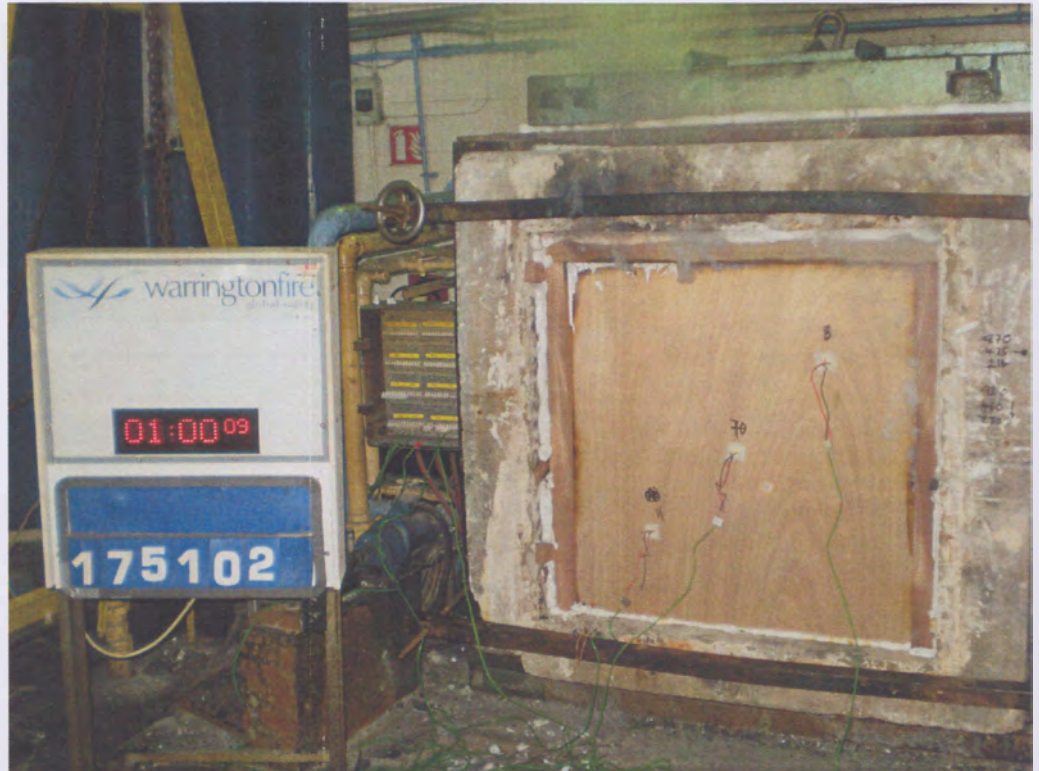
The unexposed face of the doorset after a test duration of 60 minutes

53	00	Further crackling sounds are evident from the doorset.
55	00	Pulses of thick white smoke issue from the closer position of the doorset.
58	00	The top left hand corner of the leaf visibly distorts towards the furnace chamber. Sustained flames issue from this area. The area is sealed to allow further examination of the closer.
60	00	There are no signs of flaming or loss of impermeability from the closer position.
65	00	No further significant visible changes are evident at this time.
70	00	There are no signs of flaming or loss of impermeability from the closer position. The test is discontinued at the sponsors request.

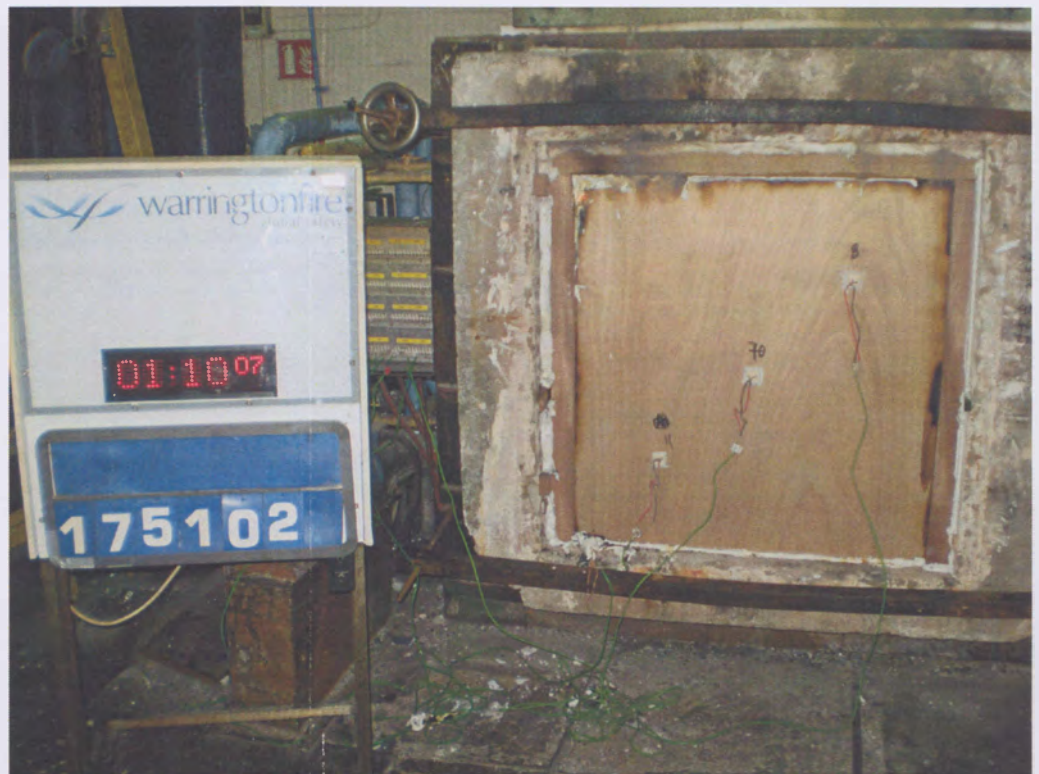
The unexposed face of the doorset after a test duration of 70 minutes
