Report: Chit/RF11054 Revision A

A fire resistance test performed on 2No.
single leaf single acting doorsets

Test conducted in accordance with
BS 476: Part 20/22: 1987

Prepared for: Firestop Manufacturing
Ltd
4 Wyvern Buildings
Grove Industrial Estate
Dorchester
Dorset
DT1 1ST

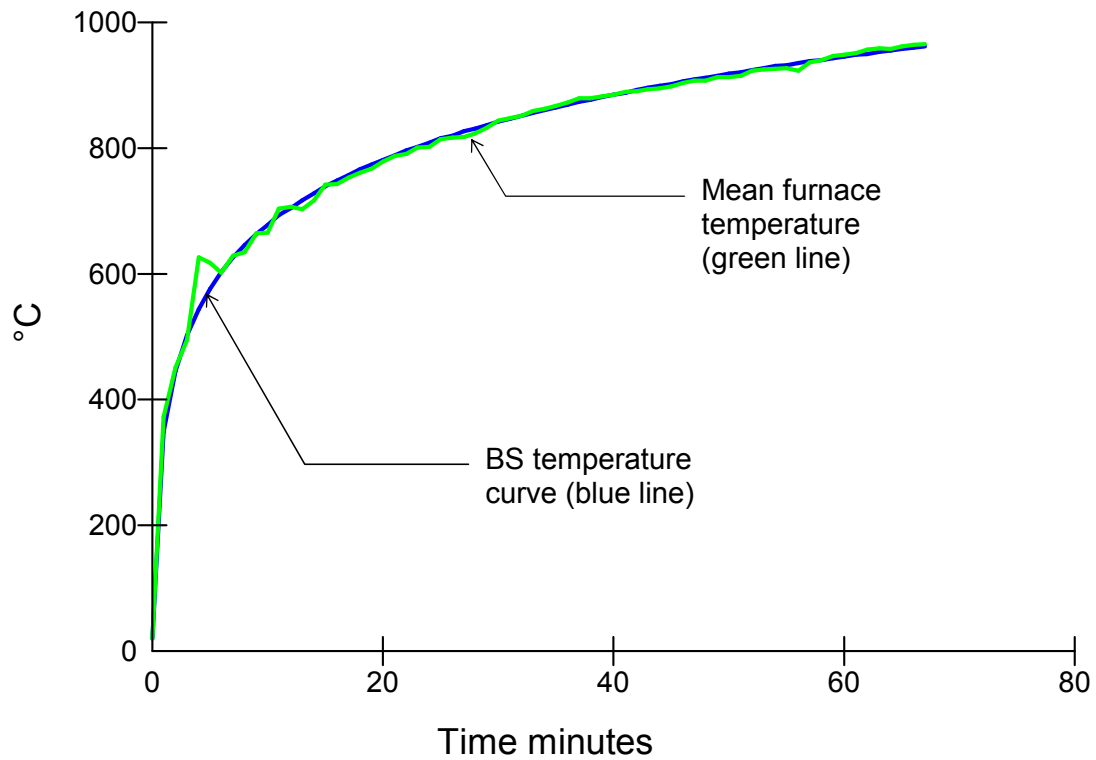
6.1 Furnace temperature curve

- 5.4 The furnace was controlled to follow the temperature/time relationship specified in BS 476: Part 20: 1987 as closely as possible, using the average of nine thermocouples suitably distributed within the furnace. The temperatures recorded are shown graphically in Section 6.1.

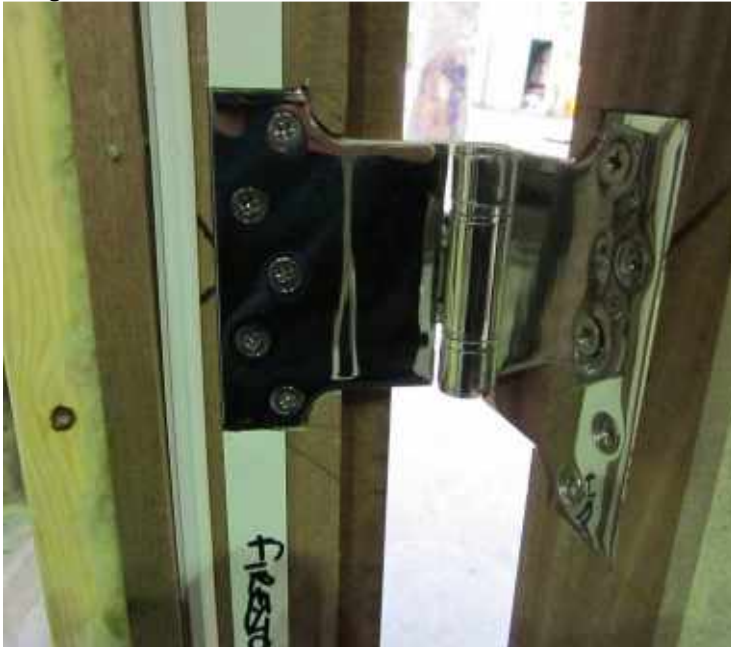
Hinge – doorset A

Pre test photographs including Intumescent interruptions due to hardware

Make/type	Size (mm)	Location
Around hinges	Fully interrupted	-	Hinge blade fully interrupts seal in frame reveal
Under hinge blade	Firestop Manufacturing Ltd intumescent sheet material Product reference FS318	0.8 thick	Fitted under the hinge blade on frame and leaf
Around latch body	Firestop Manufacturing Ltd intumescent sheet material Product reference FS318	0.8 thick	Fitted around the body of the latch
Under latch forend	Interdens	1 thick	Fitted under the latch forend
Around latch keep	Fully interrupted	-	Latch keep fully interrupts seal in frame reveal
Under latch keep	Interdens	1 thick	Fitted under the latch keep
Under drop down seal	Firestop Manufacturing Ltd intumescent sheet material Product reference FS318	0.8 thick	Fitted lining the drop down seal rebate
Around eye viewer	Firestop Manufacturing Ltd intumescent sheet material Product reference FS318	0.8 thick	Fitted lining the eye viewer cut out aperture

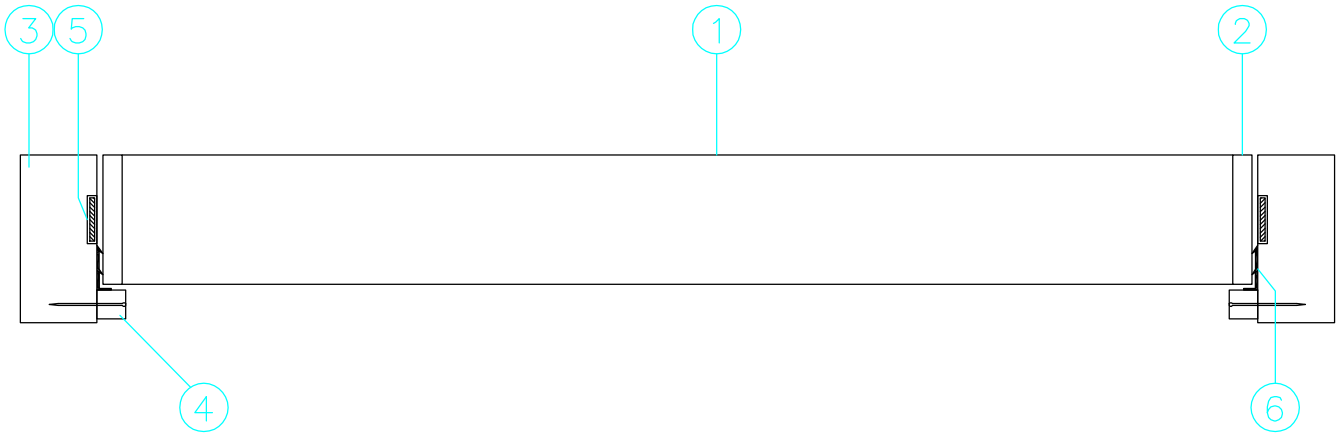
Section A-A

Horizontal cross-sections

4 Description of construction (refers to Figures 1 to 4 of the appendix)
